## TEST REPORT

No. : XMIN2506001317CM02-1\_EN

Sample Name : MSPC Laminate Floor by STONE FLOOR

Other Information : Product Description: Mineral Stone Polycomposite (MSPC)

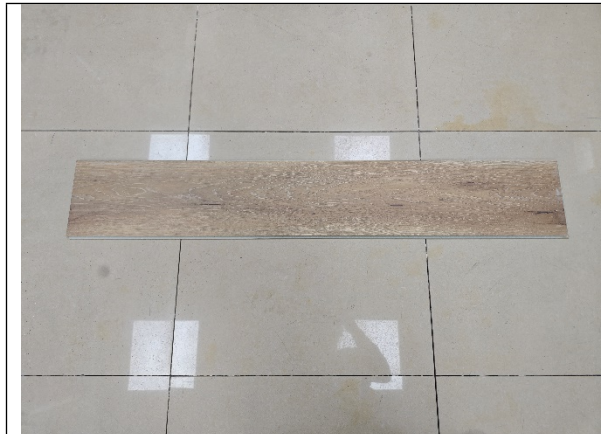
### Original Sample Photo:

Sample Description: See photo
